# Nissink | Business Glass B.V.

Delamination Issues with laminated glass

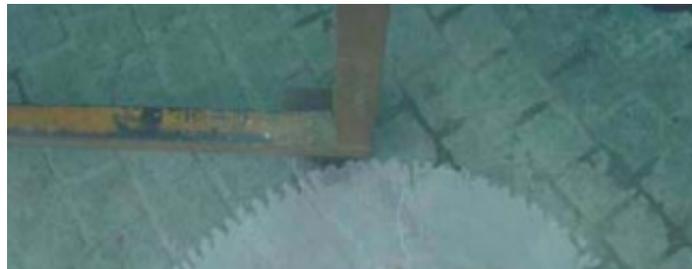
'Sunburst' delaminations (see Figure 1) in some projects have undoubtedly caused concern in the glazing industry. This type of delamination is generally the result of poor manufacturing processes, which impart stresses at locations at the edges of laminated glass, often combined with thinning of the PVB. Optical distortion is also normally evident at these locations. The most common cause of this type of localized delamination is the use of clamping devices on the edges of laminated tempered glass during the autoclaving of the laminated glass. While the quality of the glass may appear to be satisfactory at time of dispatch of the glass from the factory gradual release over time of the stresses imparted to the glass at the locations that were clamped may result in 'sunburst' delaminations. As detailed by Jorma Vitkala in his Glass Processing Days 1999 paper, 'Low-E Tempering - The Latest Results' with laminated tempered or heat strengthened glass special attention needs to be paid to the glass quality in relation to flatness and edge-curving. "If any glass is heated unevenly in the tempering process there is a tendency for the edges of the glass to curl and this is especially the case with pyrolytic Low-E coated glass". Laminated glass for point fixed applications such as canopies or frameless façade glazing requires special processing to prevent thinning of PVB around the holes in the corners of the laminates. Unless precautions are taken thinning of the PVB around holes may occur due to PVB

Fig 1: A 'sunburst' delamination; cause – poor manufacturing processes

flow in the autoclave process. Such thinning may result in the formation of bubbles or delamination around the holes following installation of the glass.

1. 'Sunburst delaminations' can be avoided by the use of good laminating practices and in the case of laminated heat treated glass by use of heat treated glass of a suitable quality for lamination. Mechanical force should not be employed to the edges of laminates during the autoclaving process.

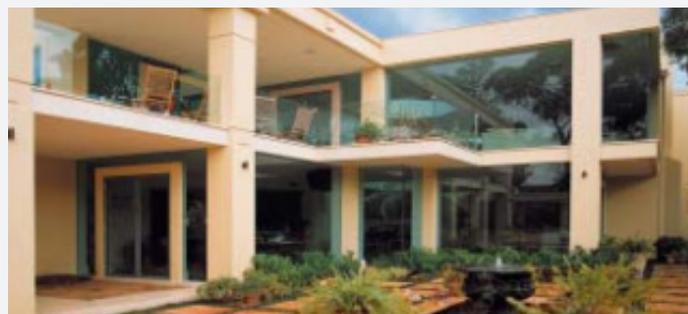
Fig 2 : Five-year old residence in Melbourne exemplifies projects in which laminated glass containing B14 PVB have exhibited no edge delamination.

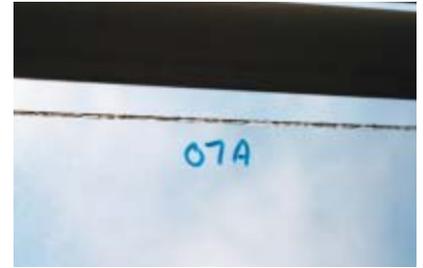
Fig 5: Open edge of a typical B14 laminate after 54 months of Florida Exposure

inch (>6.4 mm) Tables 1 and 2 show the results after the 54-month period for the laminates containing B14 PVB interlayer and Type X PVB interlayer respectively. Figure 5 shows a picture representative of the exposed edges of laminates containing B14 interlayer after 54 months of Florida exposure while Figure 6 shows the exposed edge of a laminate containing Type X interlayer after the same 54 months of Florida exposure. Figure 7 shows a plot of average defect depth for the annealed B14 laminates in Table 1 as a percentage of the total number of

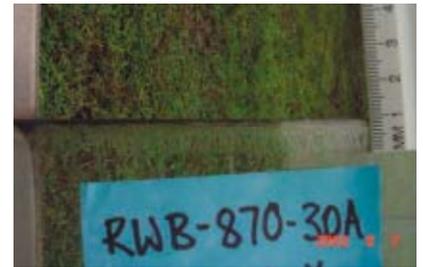
Fig 6: Open edge of a Type X laminate after 54 months of Florida exposure

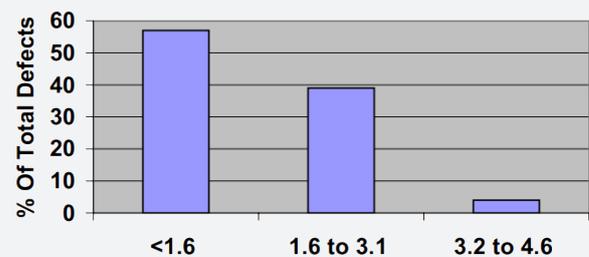
Fig 7: Plot of defect depth for B14 annealed laminates after 54 months of Florida exposure

defects. 57% of the edge defects are less than 1.6 mm (1/16 inch) in depth, 39% of the edge defects are between 1.6 mm and 3.1 mm (1/8 inch) and 4% of the total exposed edge length had defects between 3.2 mm and 4.7 mm (3/16 inch) in depth. The data from Tables 1 and 2 are summarized in Table 3 and Figure 8.

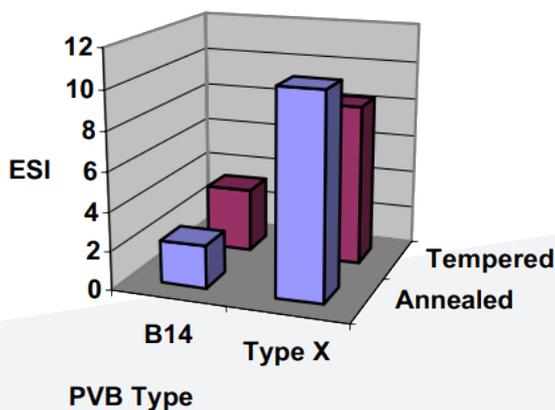
Fig 8: ESI data by PVB and glass type

A considerable difference can be seen in the edge stability performance of exposed edges of laminates containing B14 interlayer versus those containing Type X interlayer. It is believed that the minor degree of edge delamination seen in the Florida studies with B14 is the result of thinning of the PVB at the very edge of the laminate caused by a small amount of PVB flow at the edges during the autoclave process. This mechanism has been demonstrated with laminated glass containing holes for point fixing. As in the case of holes in laminated glass, it is believed that improvements to the lamination process can prevent this small amount of PVB flow at laminate edges although this has yet to be demonstrated.

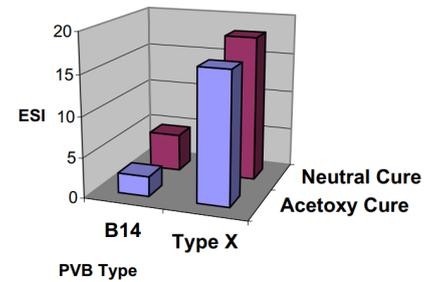
1. As with exposed edges there is a considerable difference between the results for laminates containing B14 interlayer and the now obsolete Type X interlayer.
2. There was not a great difference between the results with the two different silicone cure systems. The neutral cure silicone gave slightly higher ESI values than the acetoxycure silicone with both interlayer types.
3. With the laminates containing B14 interlayer no defects were deeper than 4 mm

The observation that ESI values with the acetoxycure silicone were little different and in fact less than for the neutral cure silicone will surprise many in the industry as it has been widely believed that neutral cure silicones result in better edge stability than acetoxycure silicones.

Fig 10: ESI data by silicone type after 4.3 years of weathering

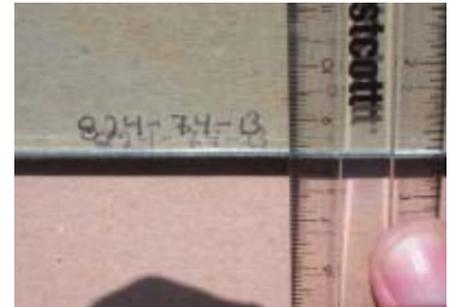
Thirteen 762 mm x 1194 mm (30" x 47") laminates with exposed edges were placed on exposure in September 1997. Inspection after 61 months of weathering has revealed no edge defects in any of the laminates (ESI of 0). Figure 11 shows a picture of the edge of laminate 824-74-13 that is indicative of all thirteen laminates. The SGP along the laminate edge forms an opaque white polymeric residue approximately 1 mm in depth. In some instances this residue has turned green due to the mold from the high humidity.

Fig 11: SGP laminate exposed edge after 61 months of Florida exposure – no edge defects
