# Nissink | Business Glass B.V.

Delamination Issues with laminated glass

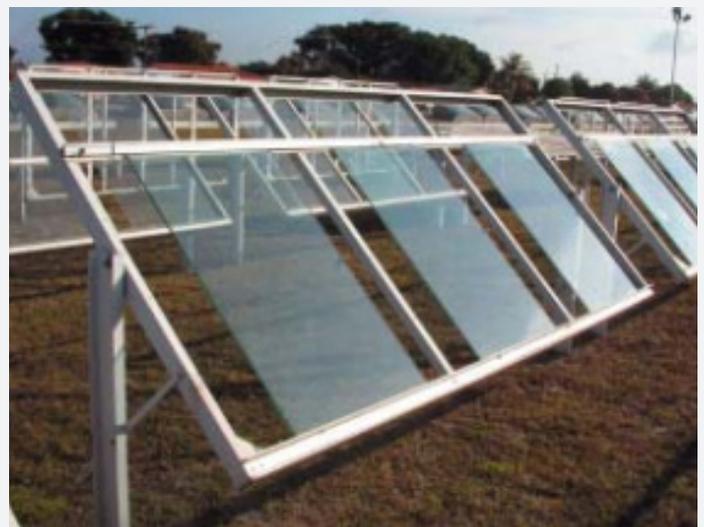
Multiple ongoing studies are being done at DuPont's Hialeah, Florida site. Laminates are positioned on racks as shown in Figure 4. These studies involve: 1. Both laminates containing PVB interlayers and laminates containing SentryGlas® Plus (SGP) ionoplast interlayer. 2. Both exposed natural edges and edges butt-joined with silicone sealants. Weathering of PVB Laminates with Exposed Edges One ongoing study compares the edge stability data of PVB laminates with exposed edges made using B14 PVB interlayer with that of PVB laminates made using the now obsolete Type X interlayer mentioned above. In this study 760 mm x 920 mm (30" x 36") laminates were made with two different types of PVB butted together at lay-up.

Fig 4: Samples of laminated glass at the DuPont weathering Site, Hialeah Florida.

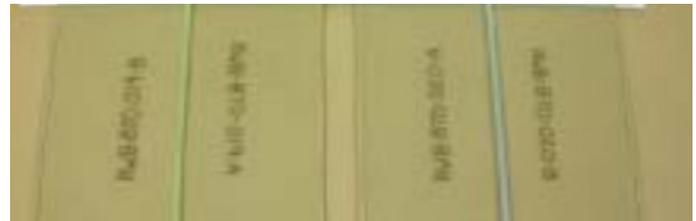
In addition to evaluating natural edge weathering other studies are being conducted in parallel to ascertain the effect silicone sealants have on edge stability. 305 mm x 305 mm (12" x 12") B14 laminates were each cut in half and butt joined together using either a neutral cure or an acetoxycure silicone sealant. After securing the butt-joined laminates to aluminum frames the

Fig 9: Silicone butt-joined samples used for Florida edge stability study

samples were placed on exposure (see Figure 9). The laminates were placed on exposure in April 1998 and last inspected in August 2002 (4.3 years of natural weathering). Table 4 and Figure 10 summarize the ESI results after 4.3 years of weathering. The following observations were made:

1. As with exposed edges there is a considerable difference between the results for laminates containing B14 interlayer and the now obsolete Type X interlayer.
2. There was not a great difference between the results with the two different silicone cure systems. The neutral cure silicone gave slightly higher ESI values than the acetoxycure silicone with both interlayer types.
3. With the laminates containing B14 interlayer no defects were deeper than 4 mm
